LONG TERM, IN-VEHICLE POLYURETHANE SEATING DURABILITY PERFORMANCE

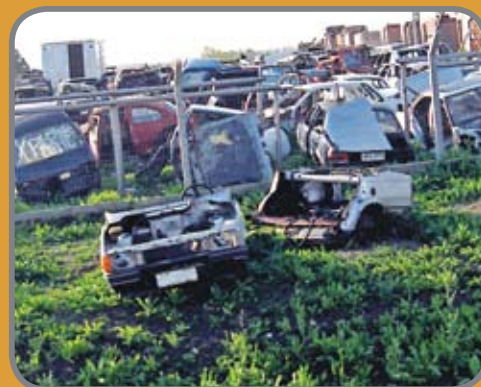
Phase 1: Auto Parts Removed From Recycling Junk-yards

- To determine if foam cushioning had retained it's initial properties or not
- Cushioning obtained from Ontario, W Virginia and Texas and odometer readings recorded (up to 326Kkms)
- Tested in an ISO 17025 accredited lab
- Cushioning fair-to-good in appearance but some parts had crumbly surfaces (Texas)
- Part hardness retained
- Foam properties mostly retained and met original specs including fatigue properties
- Foam still met FMVSS 302 flammability requirements

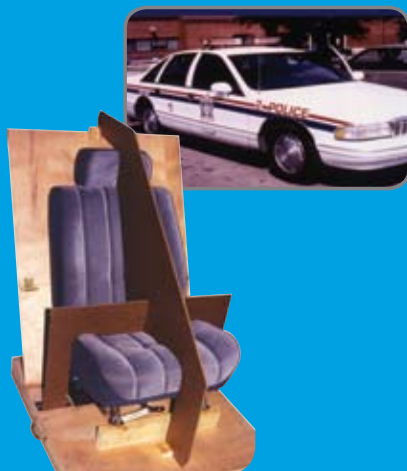
Phase 2: Police Vehicle Durability Study

- Foam and competitive material cushioning installed in police cruisers
- Cushions made with various PU chemistries or fibrous materials (natural or synthetic)
- Fully-trimmed seats installed in vehicles and used for 3/4 weeks before removal and re-evaluation in the lab for hardness, thickness change and seat creep
- Seats re-installed in vehicles for repeated periods until the equivalent of "one vehicle lifetime" of use
- PU cushions performed well, fibrous cushioning failed
- Foam cushioning tested for physicals and results compared with initial properties—essentially no change in properties after usage
- Long term seat usage resulted in retained seating comfort and maintenance of H-point

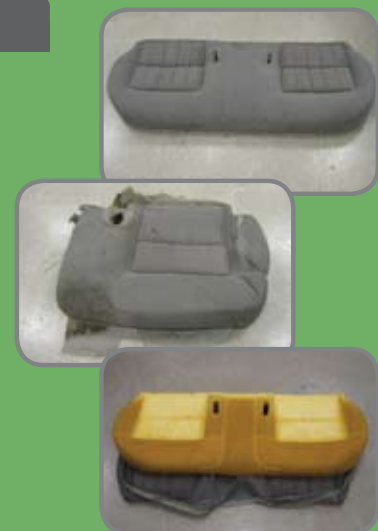
A. 1994 Chevrolet Lumina

- Vehicle scrapped due to engine problems
- Odometer reading 310K kms and used by "conservative" drivers
- Seats removed and photographed before being disassembled in a Comfort Lab
- All foam parts (front cushions and backs, rear cushion and back) examined/photo graphed before testing (photos)
- Cigarette burns through cover stock noted but cushioning foam unaffected
- Foam parts still met GM6293M spec requirements with a few exceptions and passed both FMSS 302 and the stricter GM9070P max burn rate of 63.5mm/min
